**Flood Control Project Maintenance
Levee Inspections**

Fall 2011 Levee Maintenance Deficiency Summary Report

Sacramento River Basin

Sutter Maintenance Yard Maintenance Area 0013

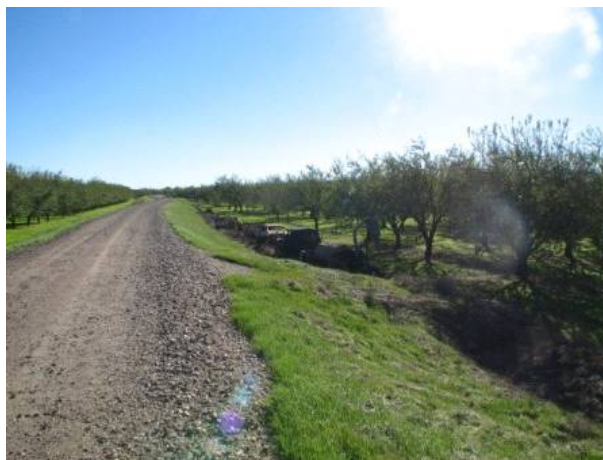
Levee Mile Report Line	1
Start Levee Mile	0.76
End Levee Mile	0.78
Location	Land Side
Category	Earthen Levee
Item	Encroachments

View of the equipment along the landside toe of the levee.

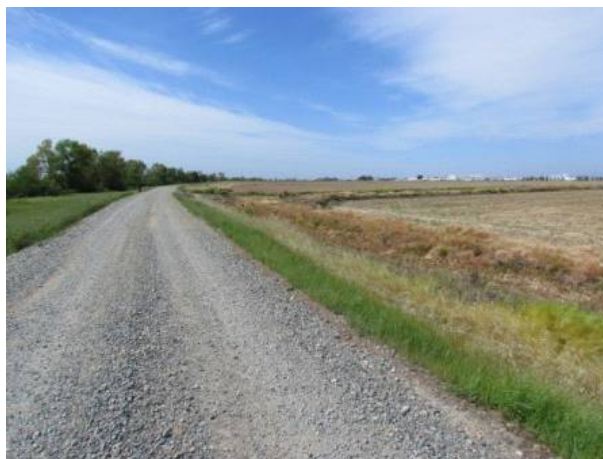
Levee Mile Report Line	2
Start Levee Mile	6.51
End Levee Mile	7.09
Location	Land Side
Category	Earthen Levee
Item	Encroachments

View of the AG ditch along the toe.

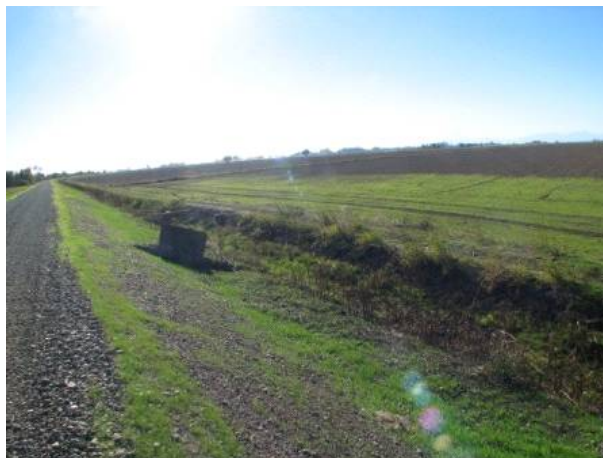
Levee Mile Report Line	3
Start Levee Mile	6.63
End Levee Mile	6.63
Location	Land Side
Category	Earthen Levee
Item	Encroachments

View of a concrete block along the toe.

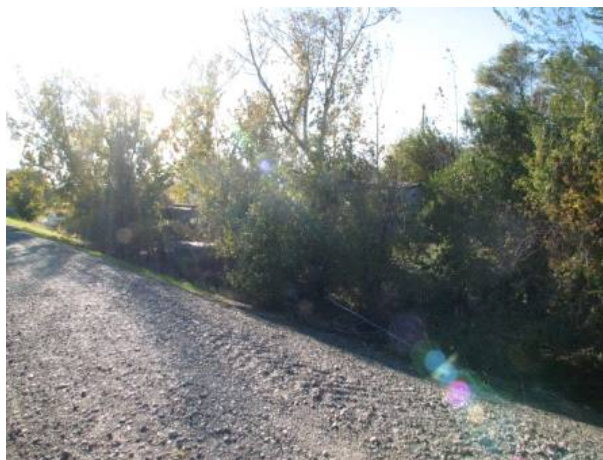
Levee Mile Report Line	4
Start Levee Mile	9.84
End Levee Mile	9.87
Location	Land Side
Category	Earthen Levee
Item	Trim / Thin Trees

View of trees that need to be trimmed along the toe.

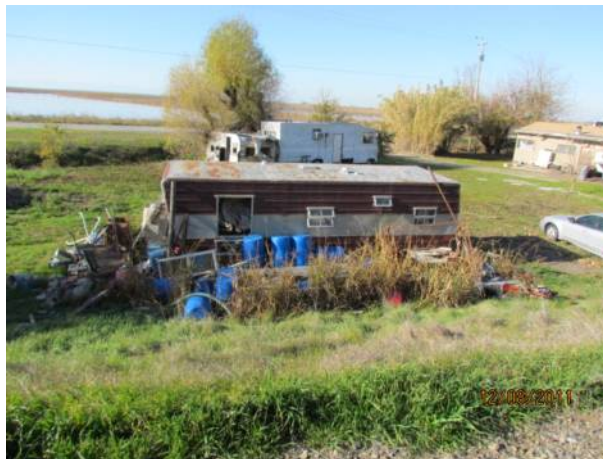
Levee Mile Report Line	5
Start Levee Mile	9.89
End Levee Mile	9.89
Location	Land Side
Category	Earthen Levee
Item	Encroachments

View of a trailer & material along the L/S toe.

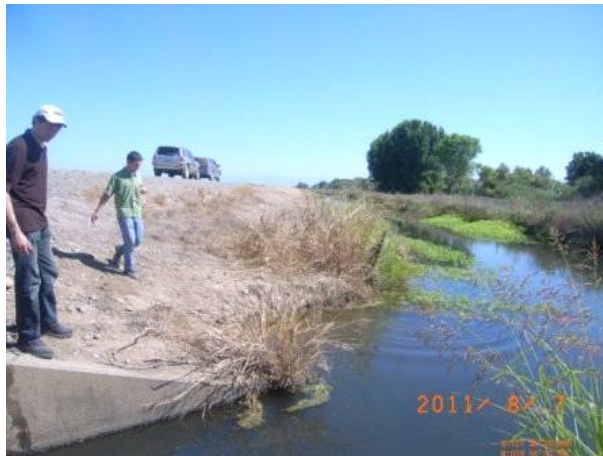
Levee Mile Report Line	6
Start Levee Mile	11.75
End Levee Mile	11.76
Location	Water Side
Category	Supplemental
Item	USACE Erosion Survey

USACE 2011 Photo #1

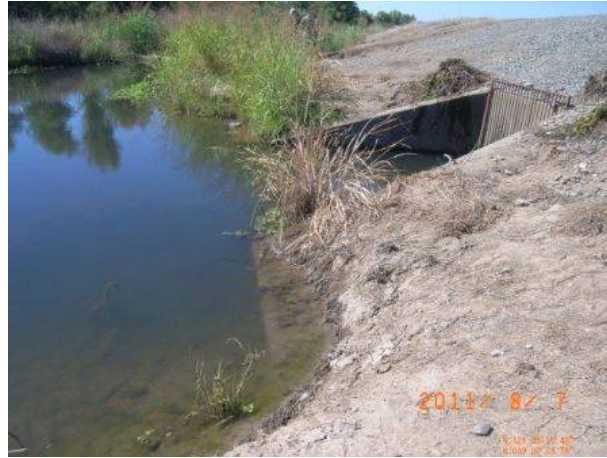
Levee Mile Report Line	6
Start Levee Mile	11.75
End Levee Mile	11.76
Location	Water Side
Category	Supplemental
Item	USACE Erosion Survey

USACE 2011 Photo #2

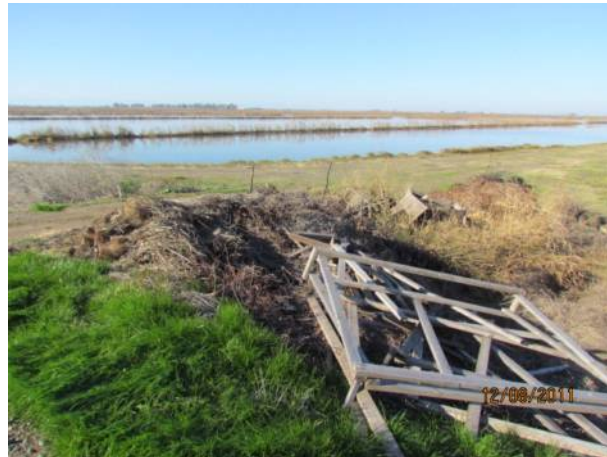
Levee Mile Report Line	7
Start Levee Mile	14.42
End Levee Mile	14.42
Location	Land Side
Category	Earthen Levee
Item	Encroachments

View of garbage along the L/S slope.

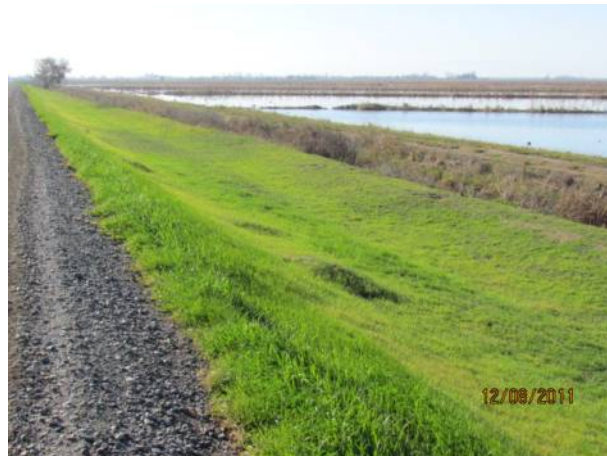
Levee Mile Report Line	8
Start Levee Mile	14.46
End Levee Mile	14.46
Location	Land Side
Category	Earthen Levee
Item	Animal Control

View of rodent holes along the L/S slope.

7	14.42	14.42	Earthen Levee	Encroachments	LS	M	Garbage	39.412752 ° -121.788662 °	39.412752 ° -121.788662 °	4 Y
8	14.46	14.46	Earthen Levee	Animal Control	LS	W	No rodents visible, but rodent burrows visible; need to backfill and compact or grout burrows.	39.412328 ° -121.789342 °	39.412328 ° -121.789342 °	1 Y
9	16.18	16.18	Earthen Levee	Animal Control	LS	C	Exterminate rodents and backfill and compact or grout burrows.	39.396920 ° -121.813808 °	39.396920 ° -121.813808 °	6 Y
10	16.45	17.42	Earthen Levee	Encroachments	LS	PO	Agricultural Ditch	39.394523 ° -121.817630 °	39.385580 ° -121.831282 °	7 Y
11	17.48	17.48	Earthen Levee	Animal Control	LS	M	Exterminate rodents and backfill and compact or grout burrows.	39.385023 ° -121.832240 °	39.385023 ° -121.832240 °	8 Y
12	17.71	17.75	Earthen Levee	Encroachments	LS	PO	Agricultural Ditch	39.382943 ° -121.835447 °	39.382635 ° -121.836012 °	9 Y

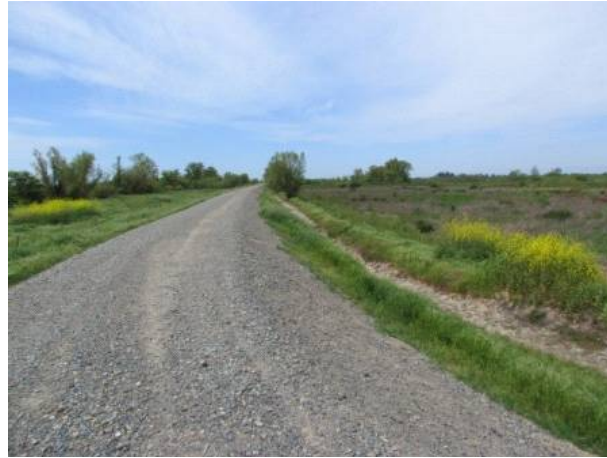
Levee Mile Report Line	10
Start Levee Mile	16.45
End Levee Mile	17.42
Location	Land Side
Category	Earthen Levee
Item	Encroachments

View of the Ag ditch along the toe.

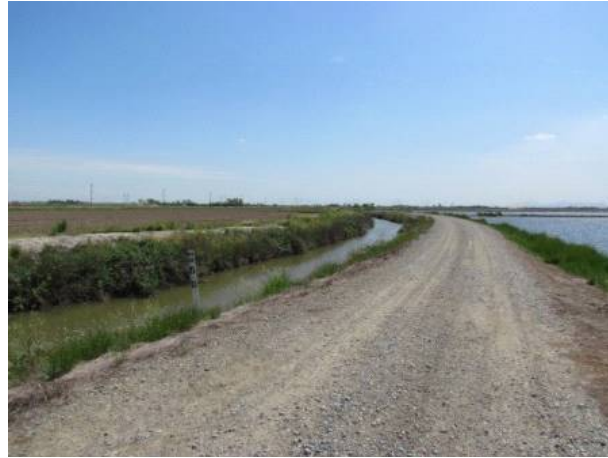
Levee Mile Report Line	3
Start Levee Mile	4.58
End Levee Mile	5.00
Location	Water Side
Category	Earthen Levee
Item	Encroachments

View of AG ditch along the toe.

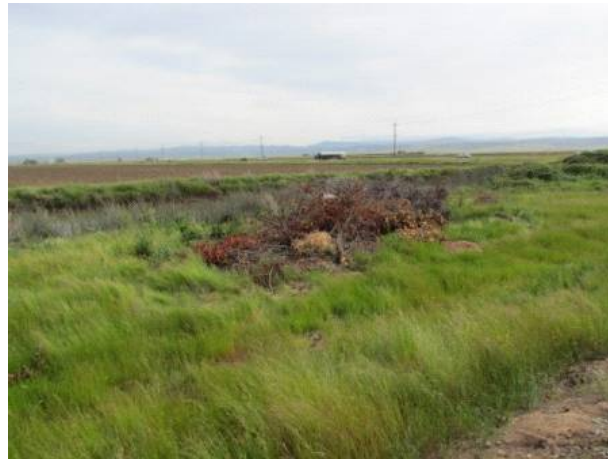
Levee Mile Report Line	5
Start Levee Mile	5.15
End Levee Mile	5.15
Location	Water Side
Category	Earthen Levee
Item	Encroachments

View of pruning & debris.

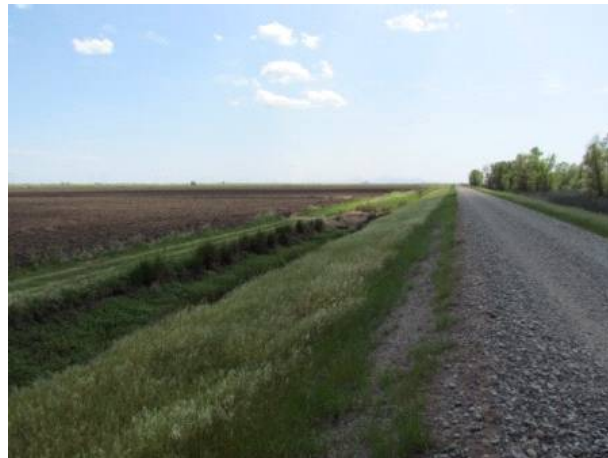
Levee Mile Report Line	6
Start Levee Mile	6.23
End Levee Mile	7.62
Location	Land Side
Category	Earthen Levee
Item	Encroachments

View of the AG ditch along the toe.

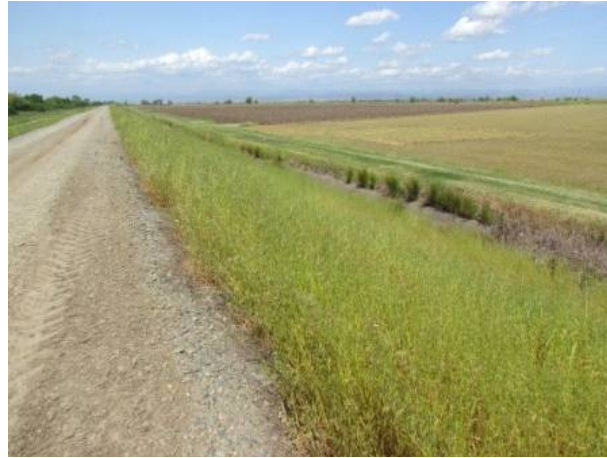
Levee Mile Report Line	7
Start Levee Mile	10.14
End Levee Mile	10.64
Location	Land Side
Category	Earthen Levee
Item	Encroachments

View of the AG ditch along the toe.

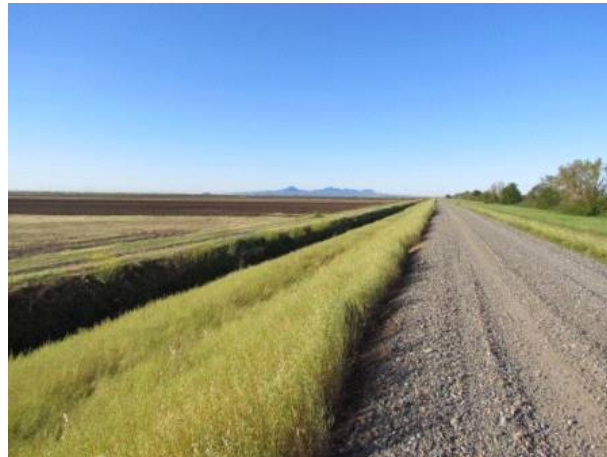
Levee Mile Report Line	8
Start Levee Mile	10.70
End Levee Mile	11.79
Location	Land Side
Category	Earthen Levee
Item	Encroachments

View of the AG ditch along the toe.

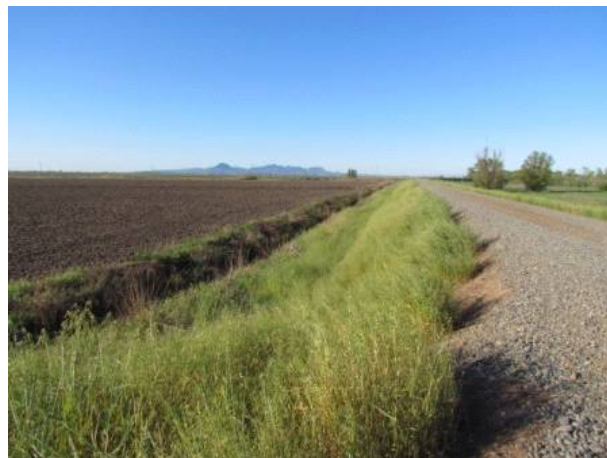
Levee Mile Report Line	9
Start Levee Mile	13.55
End Levee Mile	14.10
Location	Land Side
Category	Earthen Levee
Item	Encroachments

View of the AG ditch along the toe.

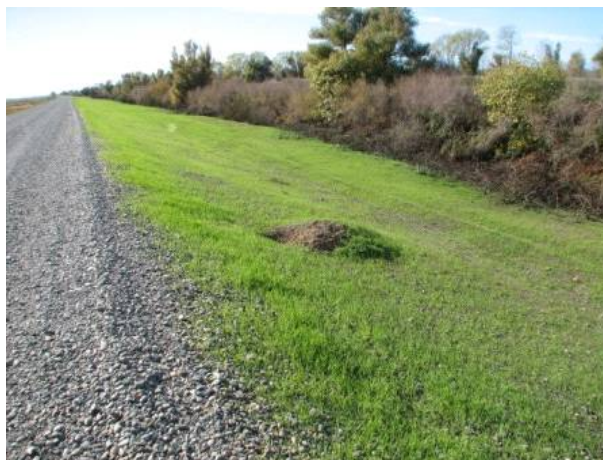
Levee Mile Report Line	10
Start Levee Mile	15.28
End Levee Mile	15.28
Location	Water Side
Category	Earthen Levee
Item	Animal Control

View of a squirrel hole along the slope.

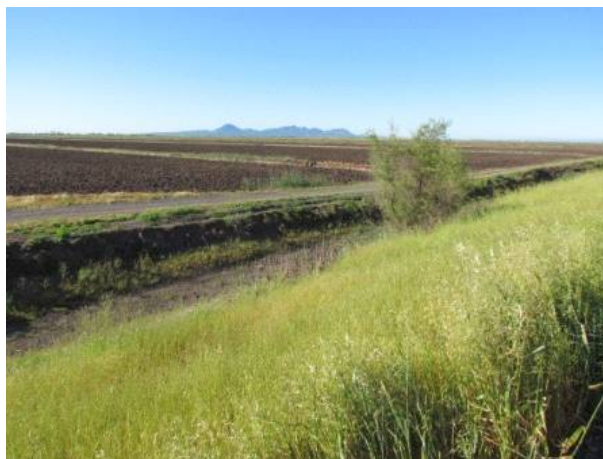
Levee Mile Report Line	11
Start Levee Mile	17.05
End Levee Mile	18.93
Location	Land Side
Category	Earthen Levee
Item	Encroachments

View of the AG ditch along the toe.

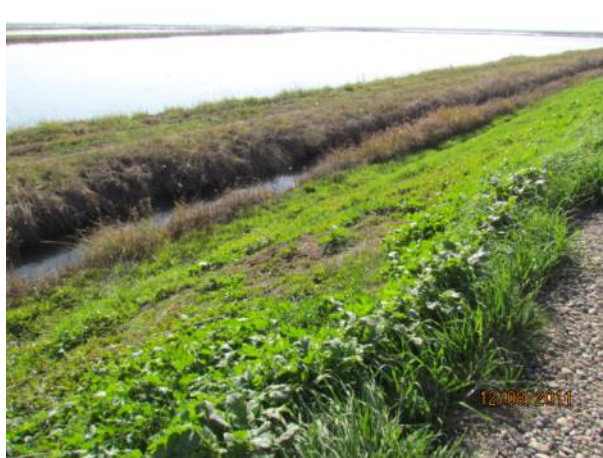
Levee Mile Report Line	12
Start Levee Mile	18.13
End Levee Mile	18.13
Location	Land Side
Category	Earthen Levee
Item	Animal Control

View of the rodent holes along the L/S slope.

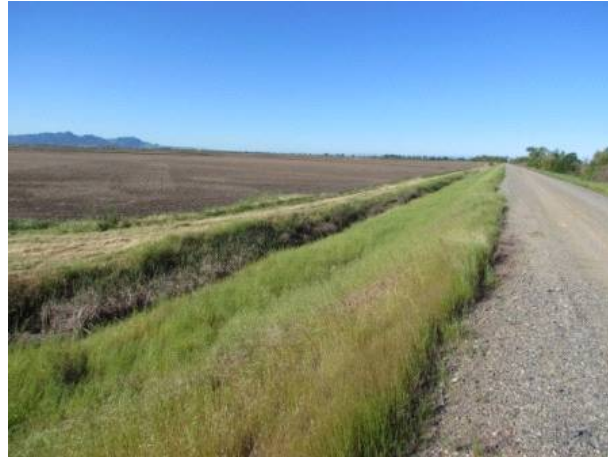
Levee Mile Report Line	13
Start Levee Mile	19.58
End Levee Mile	20.15
Location	Land Side
Category	Earthen Levee
Item	Encroachments

View of the AG ditch along the toe.

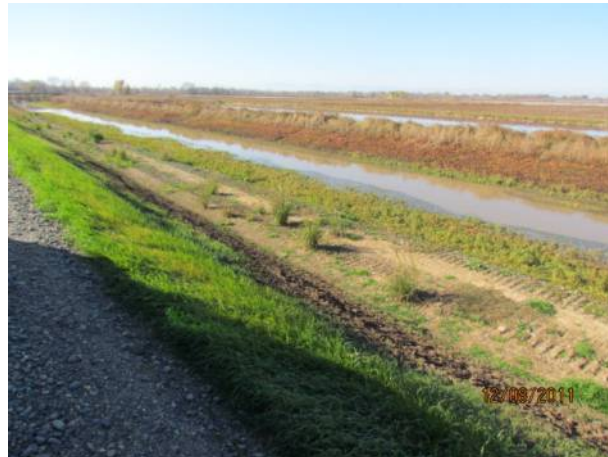
Levee Mile Report Line	14
Start Levee Mile	21.72
End Levee Mile	22.08
Location	Water Side
Category	Earthen Levee
Item	Erosion / Bank Caving

View of the erosion repaired by Sutter Yard.

14	21.72	22.08	Earthen Levee	Erosion / Bank Caving	WS	A	Schedule repair of erosion site prior to the next inspection. Inspector Comments: Repaired by Sutter Yard.	39.365167 ° -121.861810 °	39.362497 ° -121.867338 °	23 Y
15	21.72	22.08	Earthen Levee	Erosion / Bank Caving	WS	C	Schedule repair of erosion site prior to the next inspection.	39.365167 ° -121.861810 °	39.362378 ° -121.867338 °	17
16	22.38	22.38	Earthen Levee	Encroachments	LS	PO	Landscaping	39.359982 ° -121.871958 °	39.359982 ° -121.871958 °	4 Y
17	22.42	22.42	Earthen Levee	Encroachments	LS	M	Prunings	39.359707 ° -121.872555 °	39.359707 ° -121.872555 °	8 Y
18	22.69	22.69	Earthen Levee	Erosion / Bank Caving	LS	C	Schedule repair of erosion site prior to the next inspection.	39.357348 ° -121.876848 °	39.357348 ° -121.876848 °	3

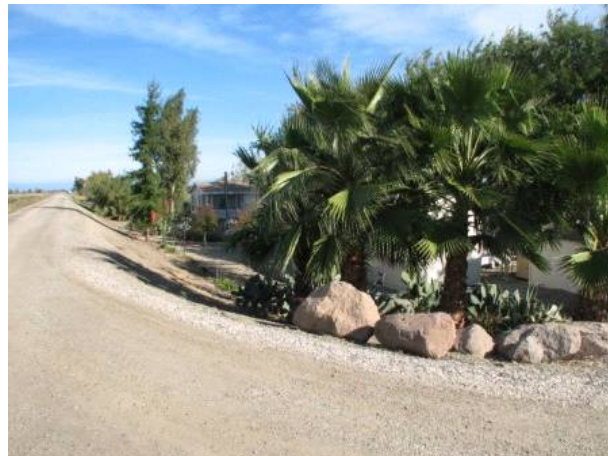
Levee Mile Report Line	16
Start Levee Mile	22.38
End Levee Mile	22.38
Location	Land Side
Category	Earthen Levee
Item	Encroachments

View of landscaping along the toe.

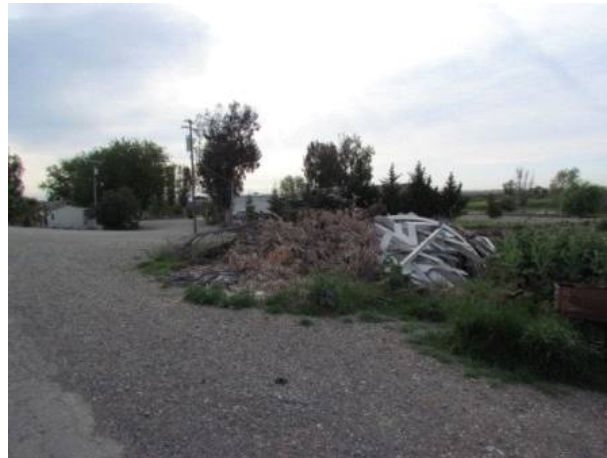
Levee Mile Report Line	17
Start Levee Mile	22.42
End Levee Mile	22.42
Location	Land Side
Category	Earthen Levee
Item	Encroachments

View of the debris & prunings.

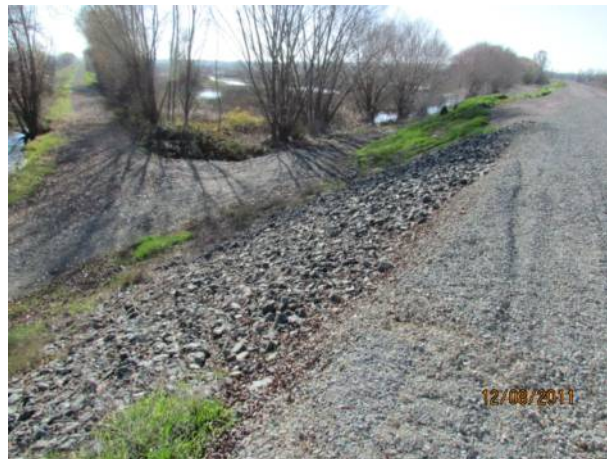
Levee Mile Report Line	19
Start Levee Mile	22.70
End Levee Mile	22.70
Location	Land Side
Category	Earthen Levee
Item	Erosion / Bank Caving

View of the erosion repaired by Sutter Yard.

LMR No.	Levee Mile		Category	Item	Location *	Rating **	Action/Comment	GPS Latitude/Longitude		Issue No. Photo
	Start	End						Start	End	
19	22.70	22.70	Earthen Levee	Erosion / Bank Caving	LS	A	Schedule repair of erosion site prior to the next inspection. Inspector Comments: Repaired by Sutter Yard.	39.357388 ° -121.877060 °	39.357388 ° -121.877060 °	24 Y
20	22.74	22.83	Earthen Levee	Erosion / Bank Caving	LS	A	Schedule repair of erosion site prior to the next inspection.	39.357083 ° -121.877747 °	39.356643 ° -121.878682 °	6 Y
21	22.83	22.85	Earthen Levee	Erosion / Bank Caving	WS	M	Note and monitor erosion site.	39.356498 ° -121.879030 °	39.356303 ° -121.879417 °	7 Y
22	22.83	22.83	Earthen Levee	Erosion / Bank Caving	LS	C	Schedule repair of erosion site prior to the next inspection.	39.356457 ° -121.879178 °	39.356457 ° -121.879178 °	2

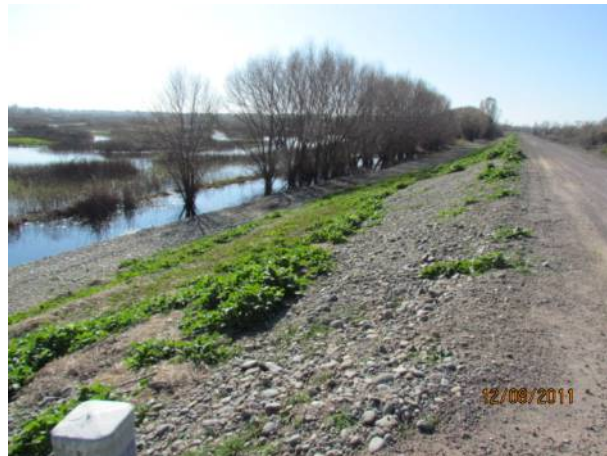
Levee Mile Report Line	20
Start Levee Mile	22.74
End Levee Mile	22.83
Location	Land Side
Category	Earthen Levee
Item	Erosion / Bank Caving

View of erosion repaired by Sutter Yard.

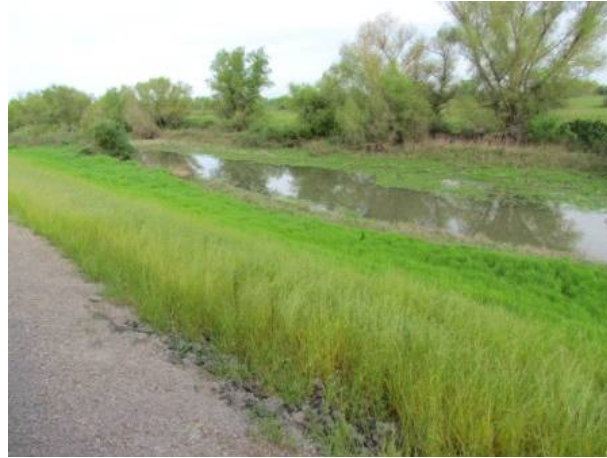
Levee Mile Report Line	21
Start Levee Mile	22.83
End Levee Mile	22.85
Location	Water Side
Category	Earthen Levee
Item	Erosion / Bank Caving

View of the along the canal.
